WELDING INSPECTION REPORT

Resident Engineer: Siegenthaler, Peter **Report No:** WIR-020923 Address: 333 Burma Road **Date Inspected:** 24-Feb-2011

OSM Arrival Time: 700 **Project Name:** SAS Superstructure **OSM Departure Time:** 1900 **Prime Contractor:** American Bridge/Fluor Enterprises, a JV

34-0006 **Bridge No: Component:** Orthotropic Box Girder (OBG)

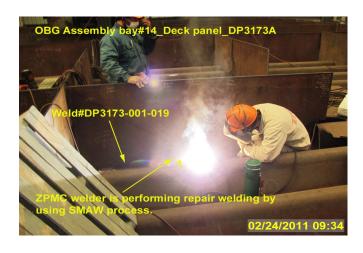
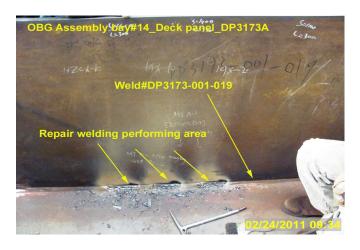
Shielded Metal Arc Welding (SMAW) repair welding of weld joint identified as DP3173-001-019. Welder is

identified as 037779. American Bridge/Fluor (AB/F) QA is identified as Mr. Shen jian. The welding variables recorded by QA personnel observed appeared to comply with Welding Procedure Specification (WPS): WPS-345-SMAW-2G (2F)-FCM-repair. The repair welding was being performed as per Welding Repair Report (WRR) No: B-WR20289. This weld was previously rejected by ZPMC QC personnel and recorded on UT report B787-UT-19227.Refer the attached photos for reference.
